The bell clappers at All Saints

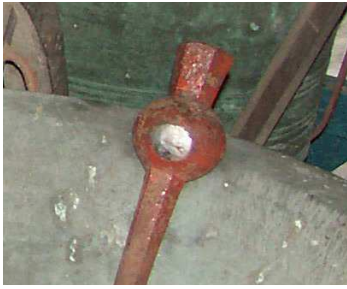
*Worn 1903
wrought iron
clapper*

Flats wear on the clapper where it hits the bell. The corresponding pit in the bell can lead to cracking, so bells are $\frac{1}{4}$ turned to present a fresh surface

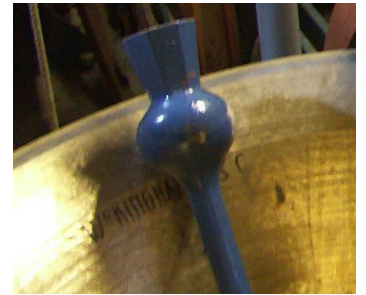
*2005 spheroidal
graphite iron
clapper*

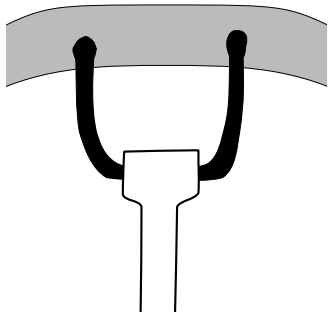
*1704 – Cast in
staple*

Historically the clapper was suspended from an iron staple cast into the crown of the bell. Modern bells have an independent staple bolted through the crown.

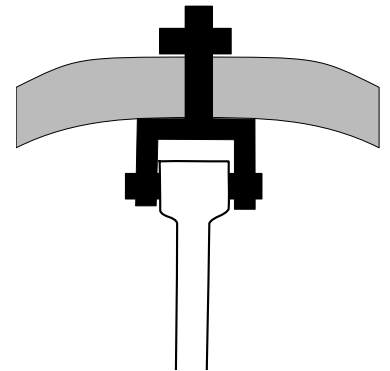
*Modern bolted
staple*

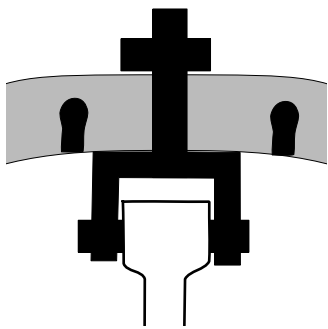
*1903 – iron
stumps in bell*

In 1903 the staples were cut off to fit modern staples, with the stumps in situ. The iron expands as it corrodes and can crack the bell.

In 2004 the stumps were drilled out and filled with resin.

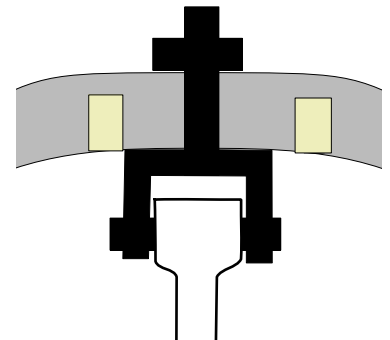
*2004 – Stumps
drilled out*

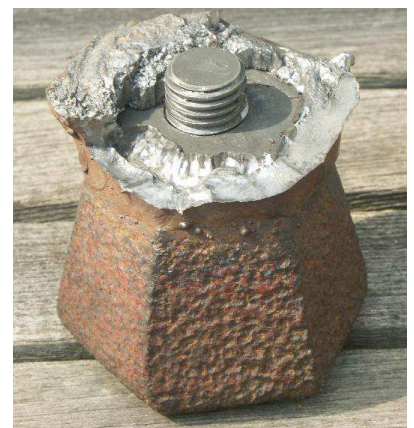
In 1988 the flight broke off the Tenor clapper. It was mended by inserting a threaded rod and welding. It failed after a year, and two more repairs also failed. The final break in 2002 was not mended, since the clappers were due to be replaced during the 2004 restoration anyway.
