Bell restoration project – Removal of the bells

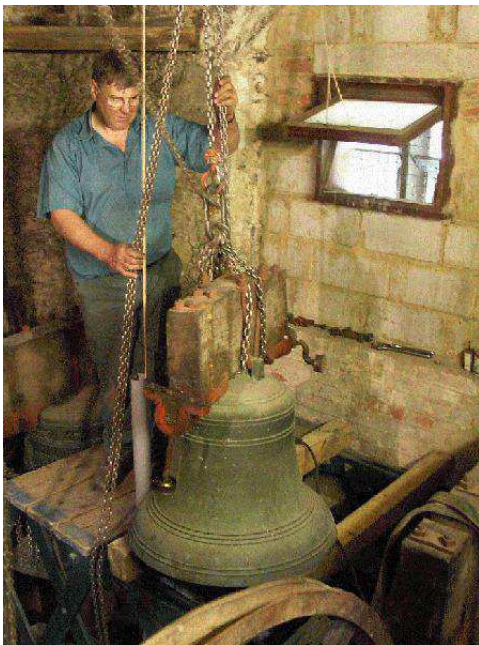
Lifting a bell from its pit

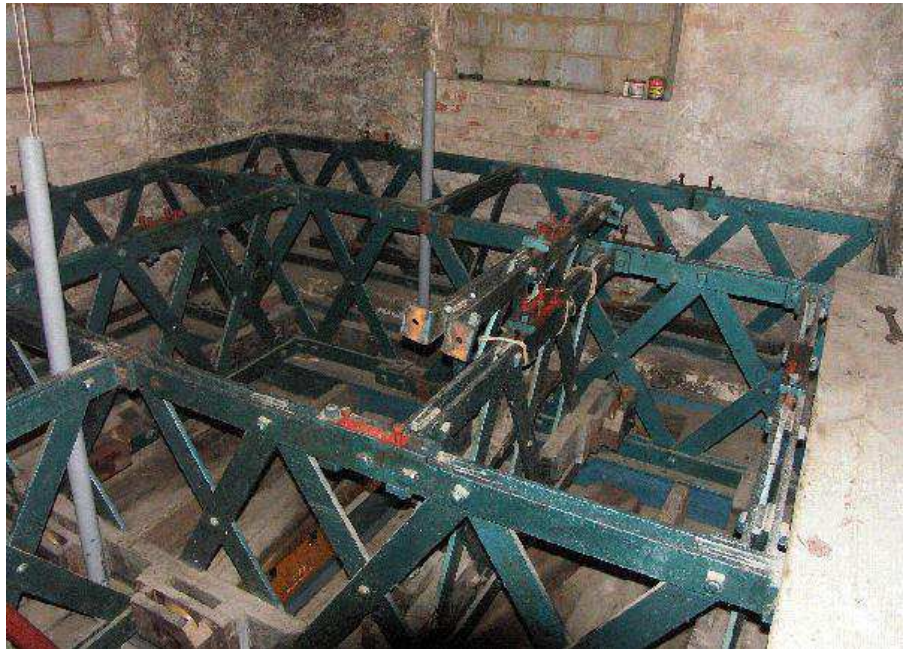
The empty eight-bell frame

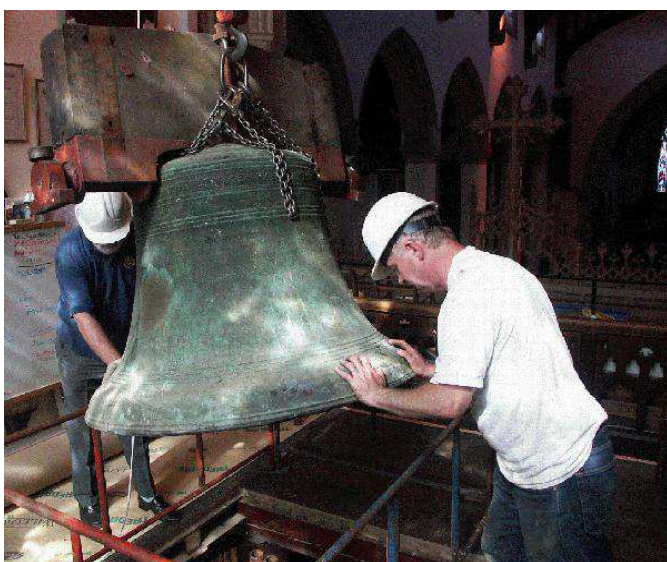
Lowering a bell through the floor

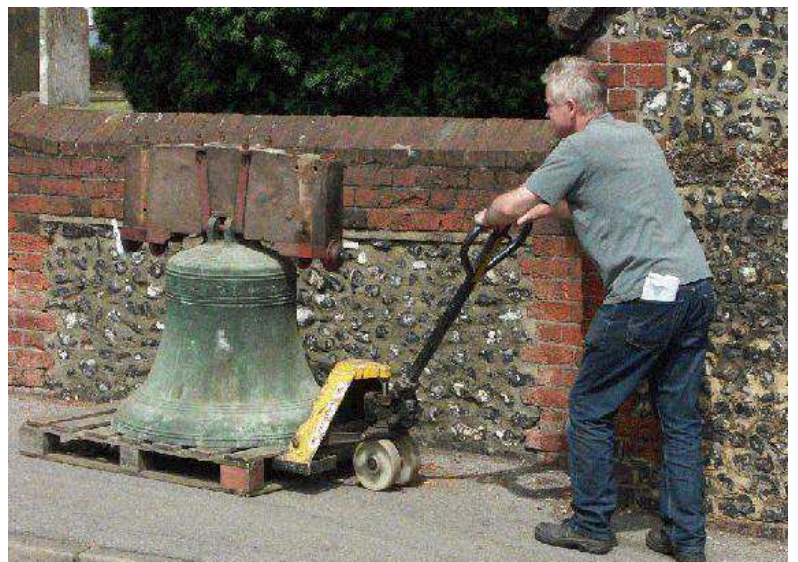
Moving a bell out to the lorry
