## Internal sound management in All Saints tower

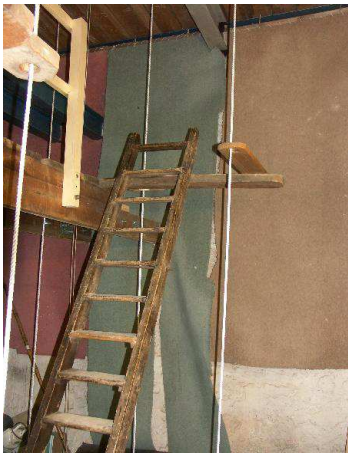
In 2005 the ringers hung old carpets on the walls of the clock room to reduce the internal reverberation and enhance the clarity of the bells as heard by the ringers below. This simple, cheap treatment proved very effective.

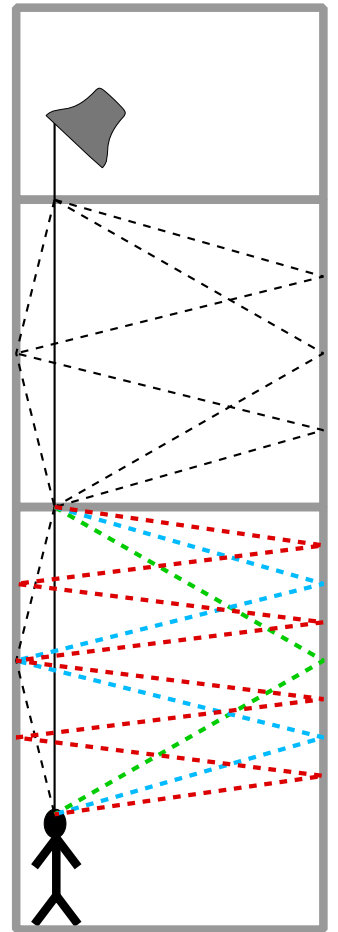
When the glass screen was installed in the ringing room it replaced a perfect sound absorber (the open arch) with a perfect reflector. On its own that would have made the internal reverberation far worse.

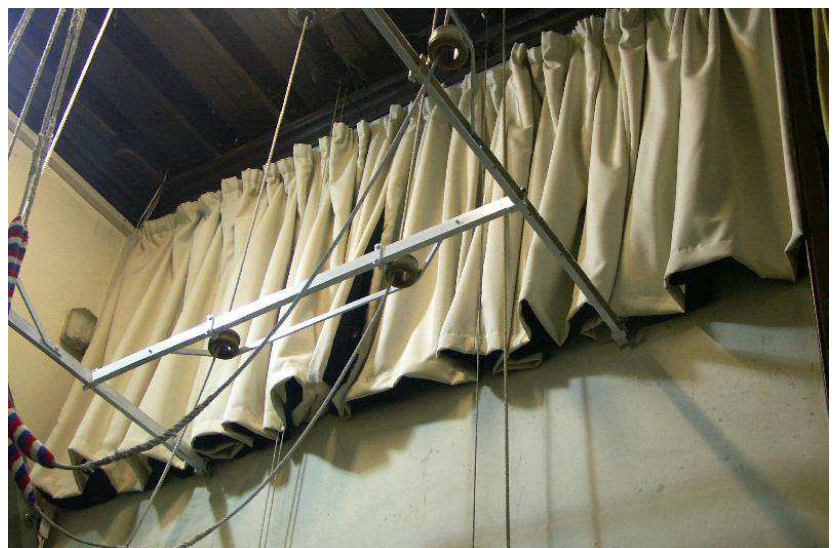
To compensate for the reflectivity of the glass, two large areas of bare wall (which were reflective) were covered with heavy drapes of acoustically absorbent material (of a type used in theatres) that provided roughly the same absorption as was lost from the open arch.
