Bell restoration project – Rehanging the Saints bells

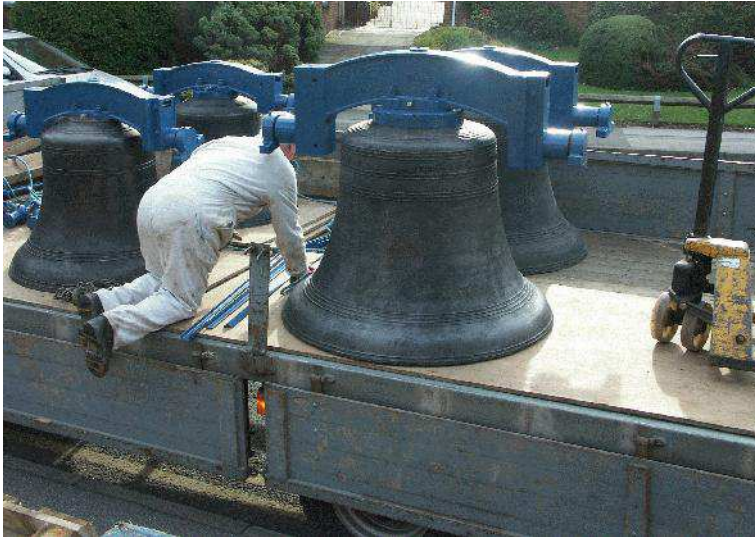
Unloading from the lorry

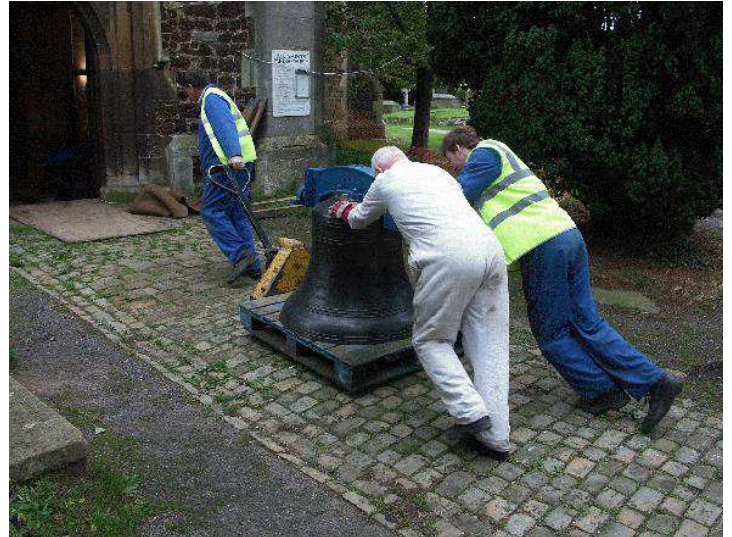
Moving a bell into the church

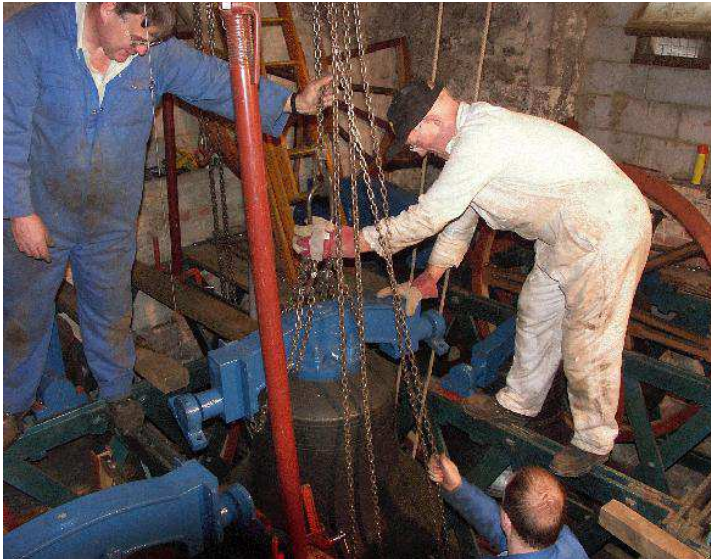
Lowering a bell into its pit

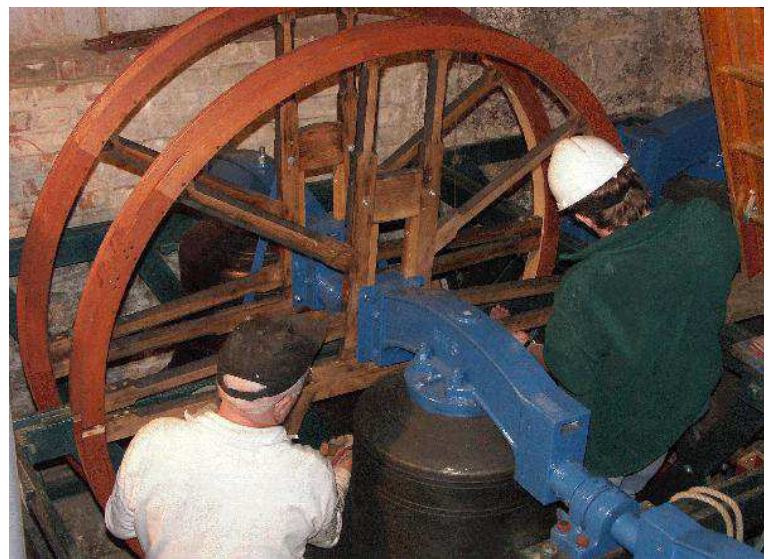
Adding wheel and fittings

After three months, the new and refurbished bells, together with new fittings, were returned to the church. The timber headstocks were replaced with iron headstocks. The wheels were rebuilt with new rims around the sound core and spokes. Everything else, bearings, pulleys, stays, sliders and rope bosses were new.

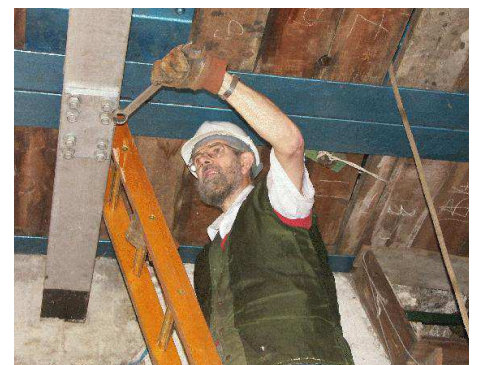
To provide added rigidity to withstand the forces created by swinging bells and extra steel beam was added underneath, and at right angles to the existing beams. The centre section of the new beam had to be removable to enable the bells to be lifted up into the frame.
